NUMBER 86 FEBRUARY, 1977

O.S.T.A.R 1976 and Multihull Safety

O.S.T.A.R. 1976 AND MULTIHULL SAFETY

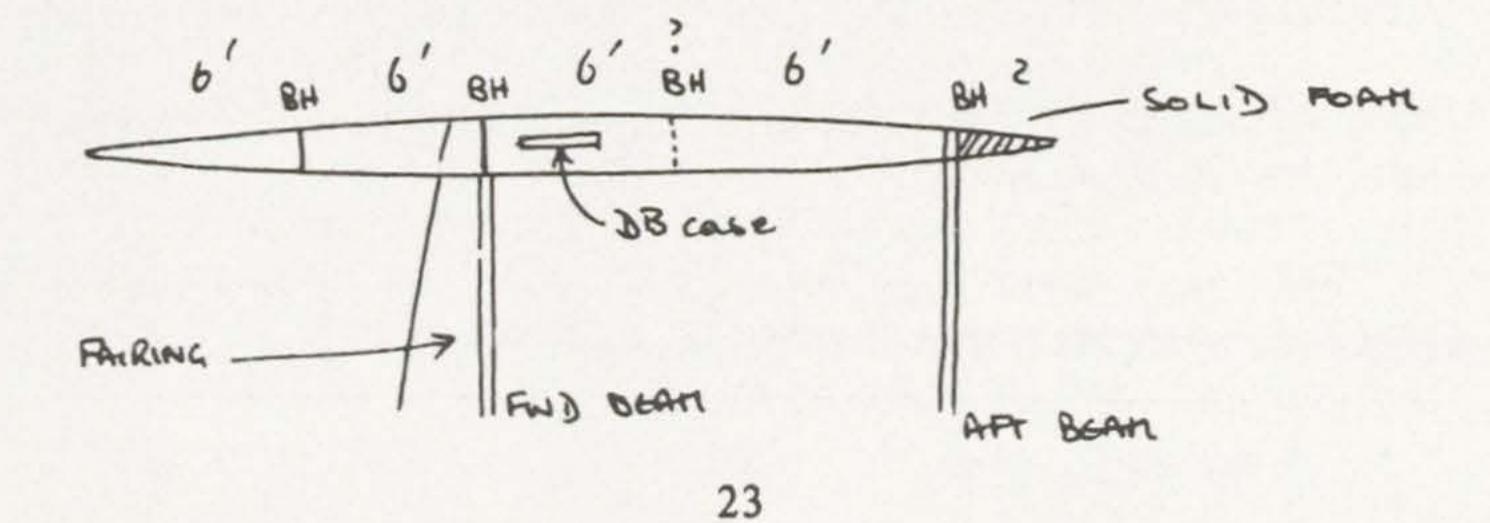
Silmaril had bulkheads at the float/beam joints, sealed, no limber holes. She also had at least one bulkhead forward of the fwd. beam. The back 2 ft. of the floats was solid foam. (If Andy built her as I asked, she also had another watertight bulkhead between the beams. All these were glassed in). There were no float hatches.

The fairings, also sealed, no hatches, could not let water into the float even if it were holed. Expansion of air from the float when the weather was hot went via main/aft beam to main hull.

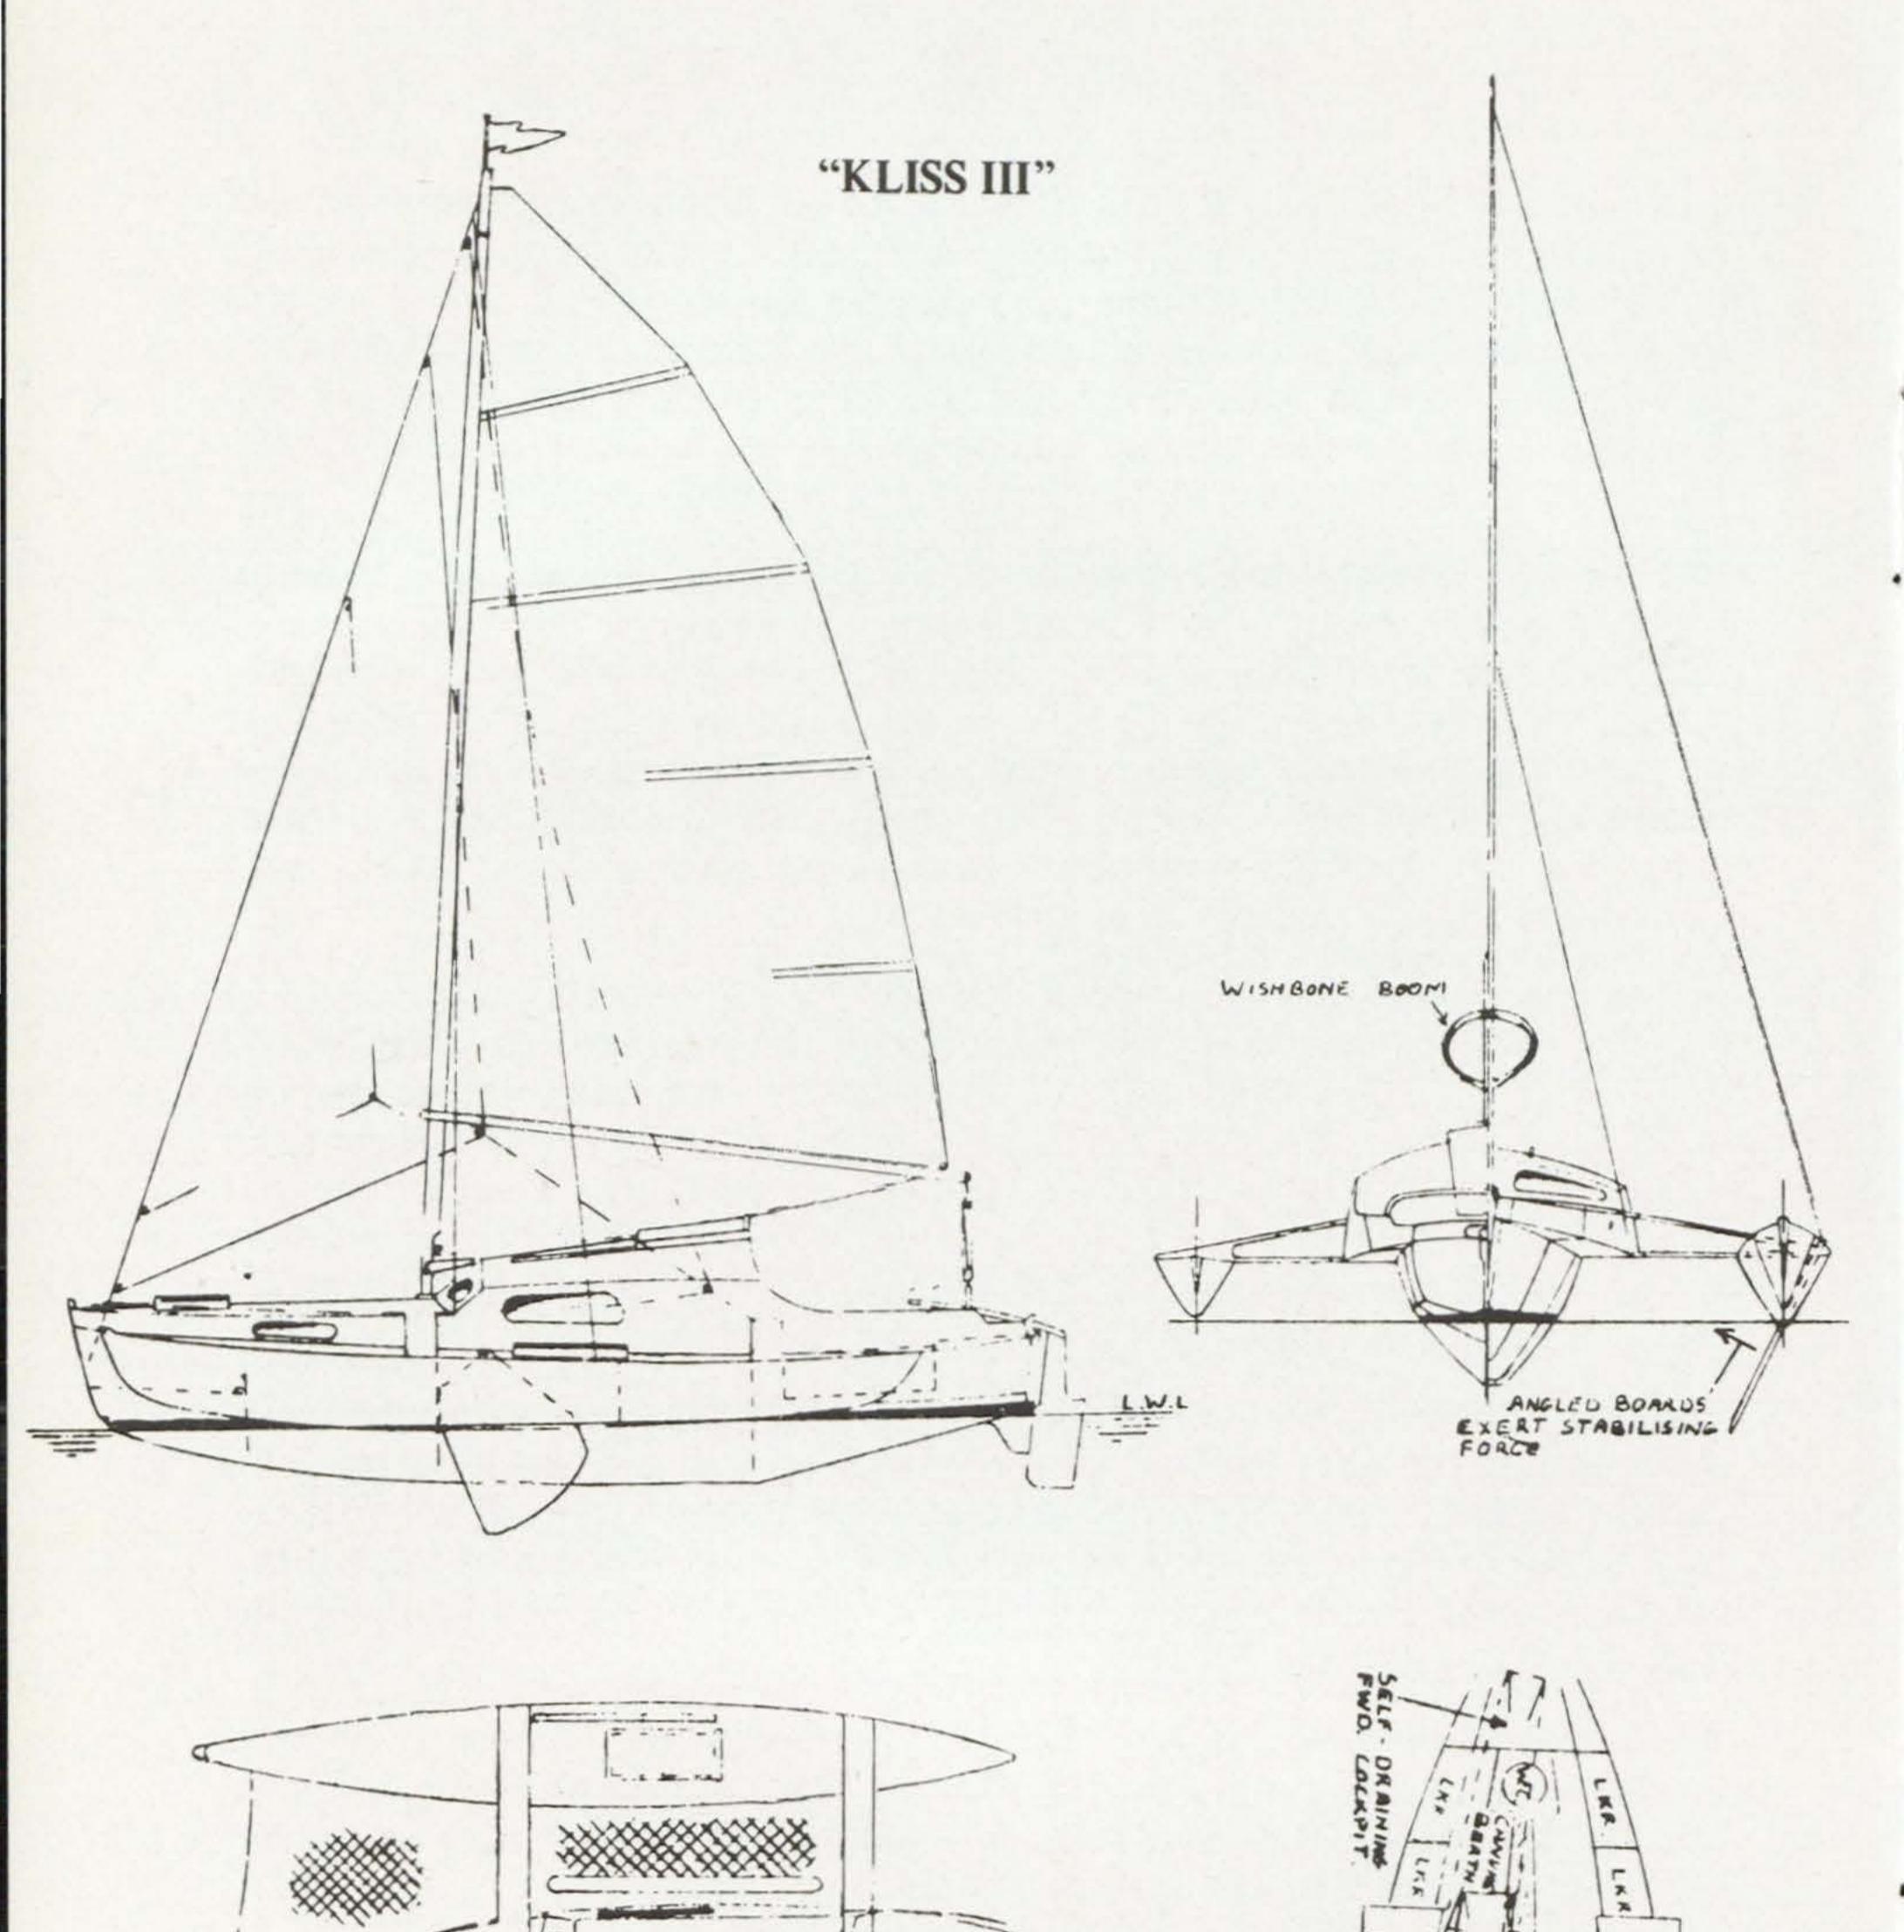
The open A-frame crossbeams, of oregon pine sheathed in fibreglass, are jointed by means of stainless fish-plates top and bottom, with numerous ¹/₄ inch through-bolts. This allows dismantling to a beam of 7 ft. 10 in. for trailing or to reduce storage space.

Length Overall . 23ft. 9in. = 7.24m, Beam Dismant. . 7ft. 10in. = 2.39m. Draft Max.... 2ft. 19in. = 0.86m. Min. 1 ft. 7in. = 0.48m. Weight Empty. . . . 1200lbs./544kg.

Weight on L.W.L. 2400lbs./1087kg. Sail Areas: -Genoa 190sq.ft./17.65m2

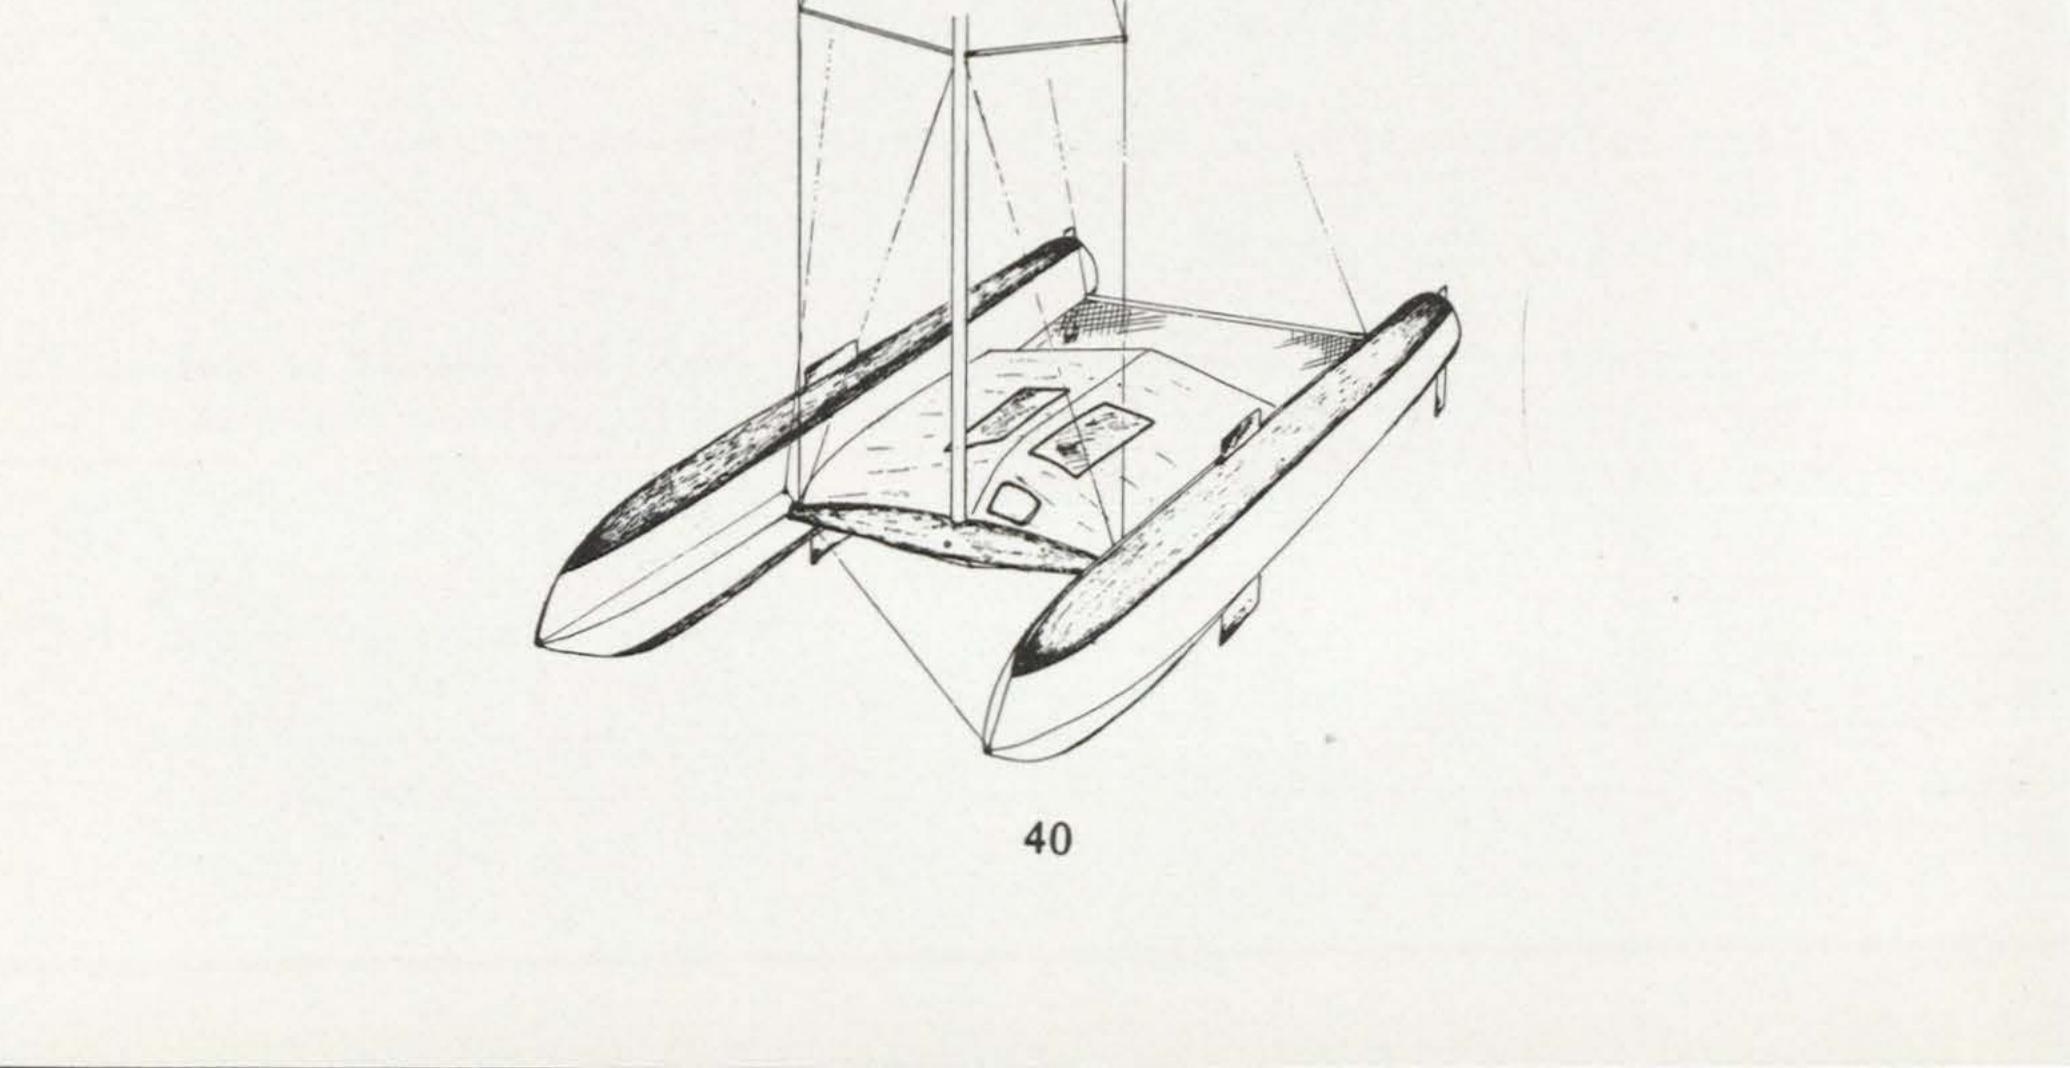
METHOD OF RIGHTING HAVKAT

Eyebolts and lifelines under bridgedeck are standard. Orange bridgedeck is standard.

Longitudinal metacentric height is twice athwartships. M.H.

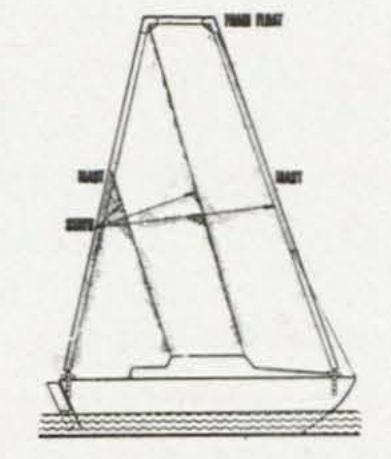
This sketch shows the flat-topped 'A' mast structure of Emoyeni. The horizontal bar at the top is filled and covered with foam plastic to form a powerful float. The three sails are set like the foresails of an ordinary yacht from stays.

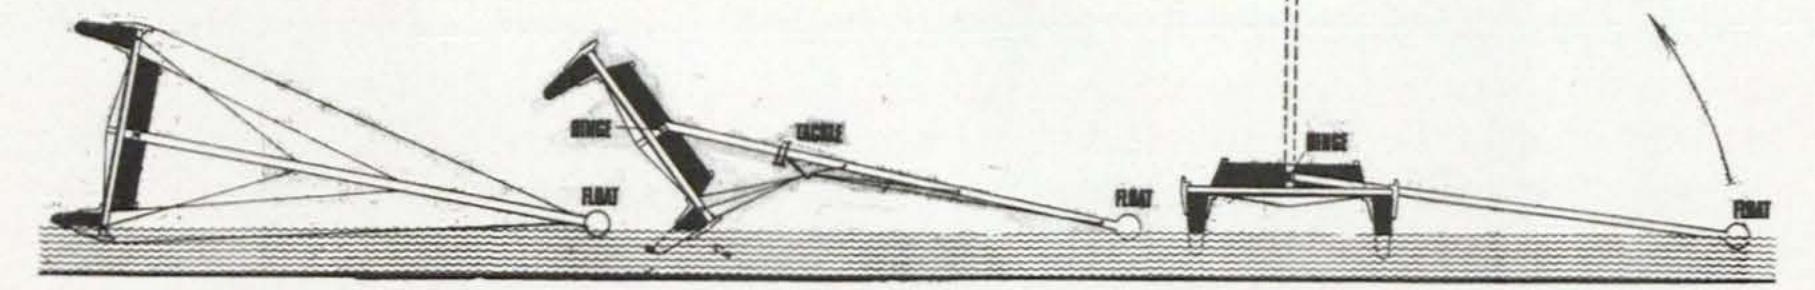
Left: Lying on her side and prevented from tipping right over by the mast-top float.

Centre: The upper rigging is released and a block and tackle is used round the lower rigging to draw it in and reduce the angle between the boat and masts. This forces the hull back into a normal position since the float cannot be submerged.

Right: The boat is back on the water with its mast lying flat but ready to be rehoisted.
